Manhole Inspection Summary

Manhole # S15CC2008MH

Insp Date: **7/26/06 10:11 AM**

Location Address: **5701 CHILHAM RD**

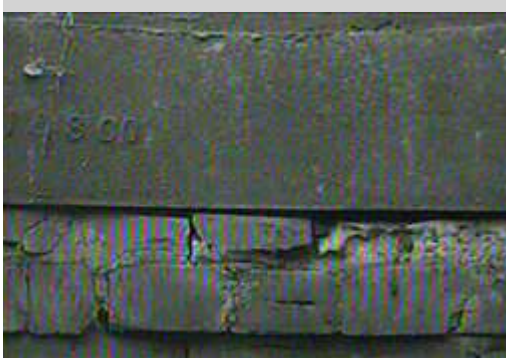
Defect

☒ **Leaks**

Condition: ☐ Sound ☒ **Cracked** ☐ Root Intrusion ☐ Loose Brick ☒ **Deteriorated**

Infiltration: ☐ None ☒ **Joint** ☒ **Cracks** ☒ **Mortar** ☐ Roots ☐ Wall

Frame leaks. Adjustment cracks, deterioration, and infiltration.

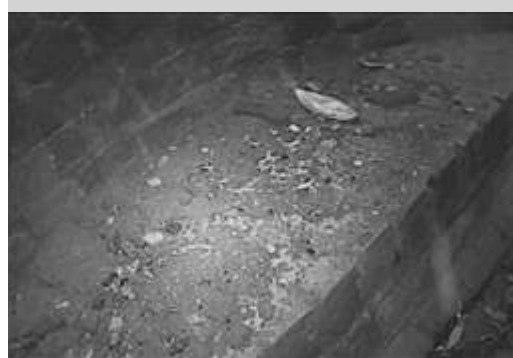
Defect

☐ Parged ☒ **Debris** (not Condition related)

Bench debris.

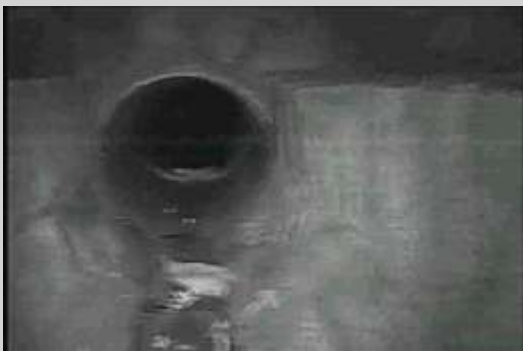
8 in. Circular Gravity Sewer Pipe In @ 6 O'Clock

Deposits: ☐ None ☐ Mud ☐ Sludge ☒ Debris ☒ Grease

Silt Depth: **0** (in.) Deposits Extent: **Light**
